Manhole Inspection Summary

Manhole # S15EE2034MH

Insp Date: **9/29/06 1:57 PM**

Location Address: **1905 KELLY AVE**

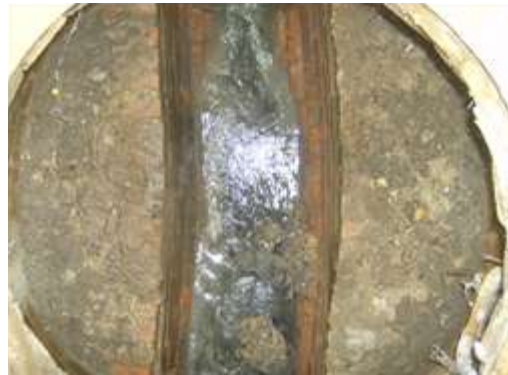
Top View

Corroded steps. Evidence of surcharge - Bench debris. Channel debris.

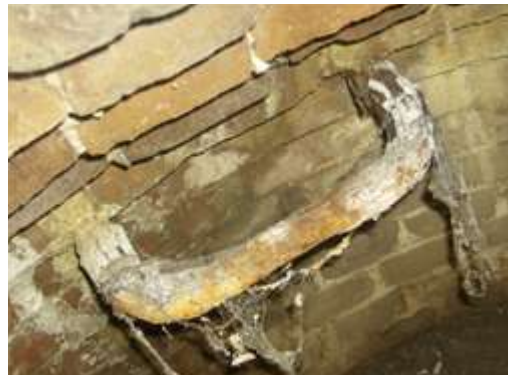
Defect

Corroded steps.

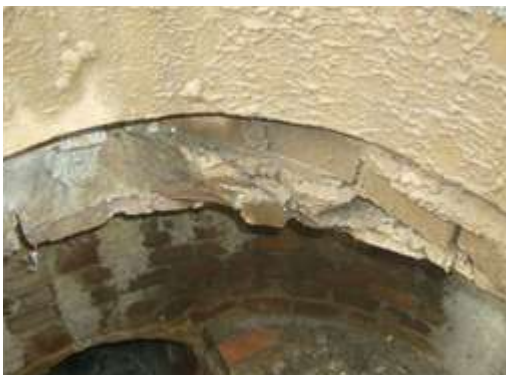
Defect

Frame leaks. Corbel deterioration and infiltration. Barrel infiltration.

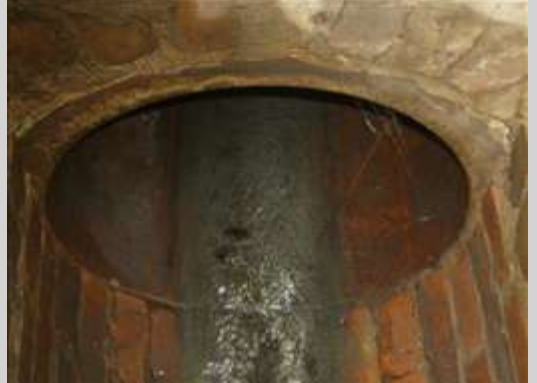
18 in. Circular Gravity Sewer Pipe Out @ 12 O'Clock

Infiltration: **Evidence** Pipe Seal Cond: **Unknown**

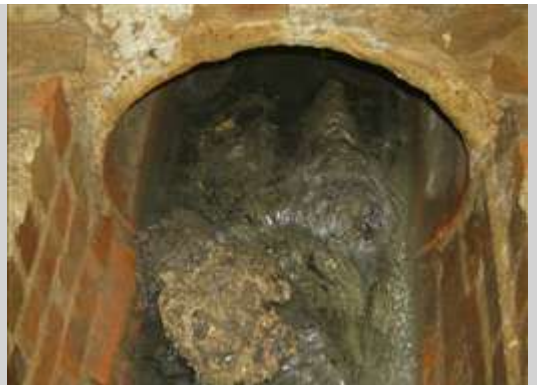
18 in. Circular Gravity Sewer Pipe In @ 6 O'Clock

Deposits: ☐ None ☐ Mud ☐ Sludge ☒ **Debris** ☐ Grease

Silt Depth: **4** (in.) Deposits Extent: **Heavy**
